# Information on Status of Nuclear Power Plants in Fukushima

Japan Atomic Industrial Forum, Inc.

Status of nuclear power plants in Fukushima as of 20:00, April 19th (Estimated by JAIF)

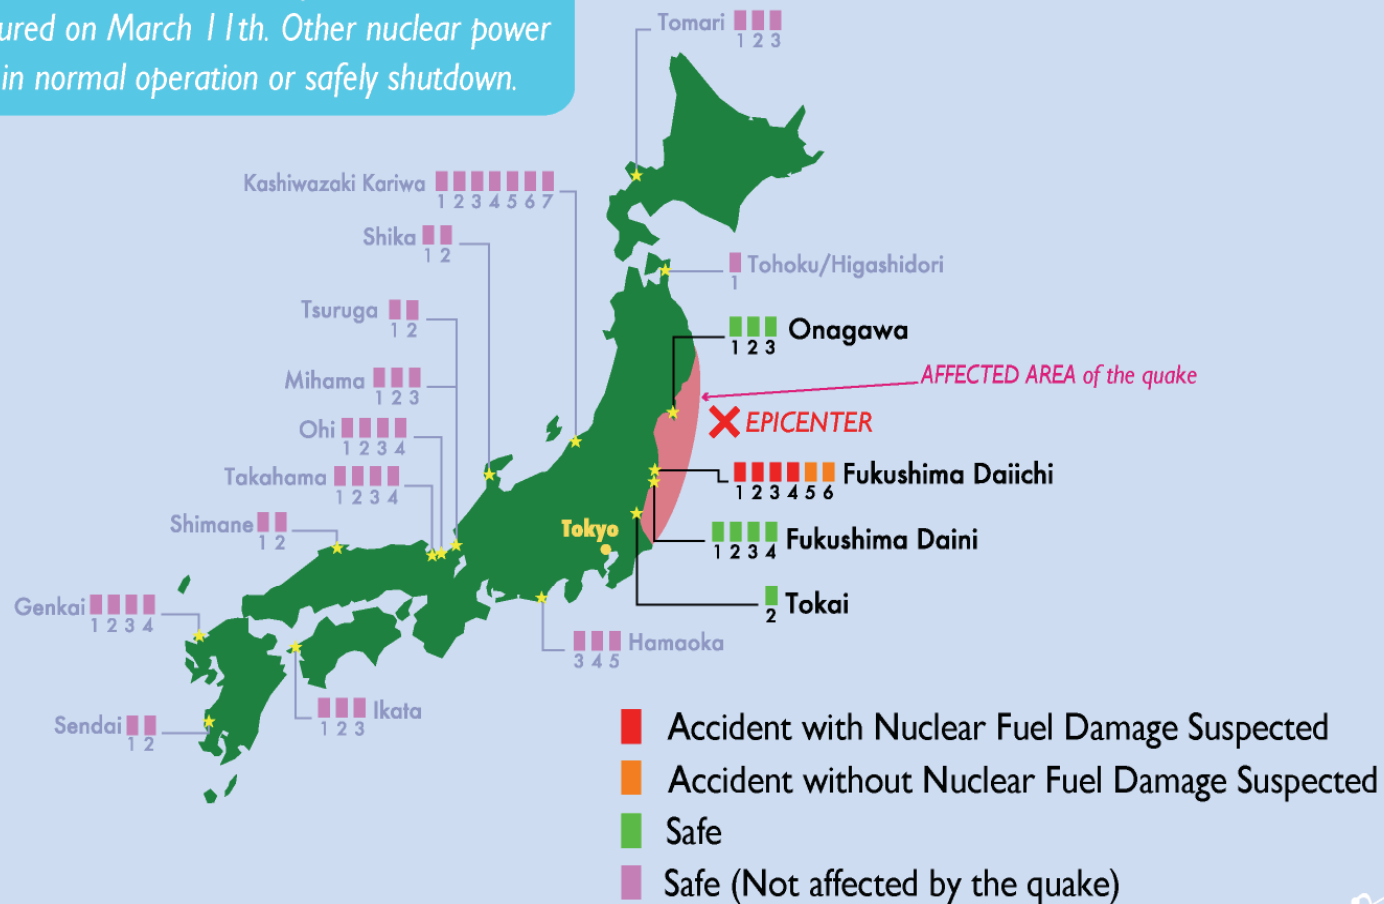
The accident that brings environmental impact is going on at several units in Fukushima Daiichi nuclear power Station after the earthquake occurred on March 11th. Other nuclear power plants in Japan are in normal operation or safely shutdown.
