Information on Status of Nuclear Power Plants in Fukushima

Japan Atomic Industrial Forum, Inc.

Status of nuclear power plants in Fukushima as of 16:00, April 21st (Estimated by JAIF)

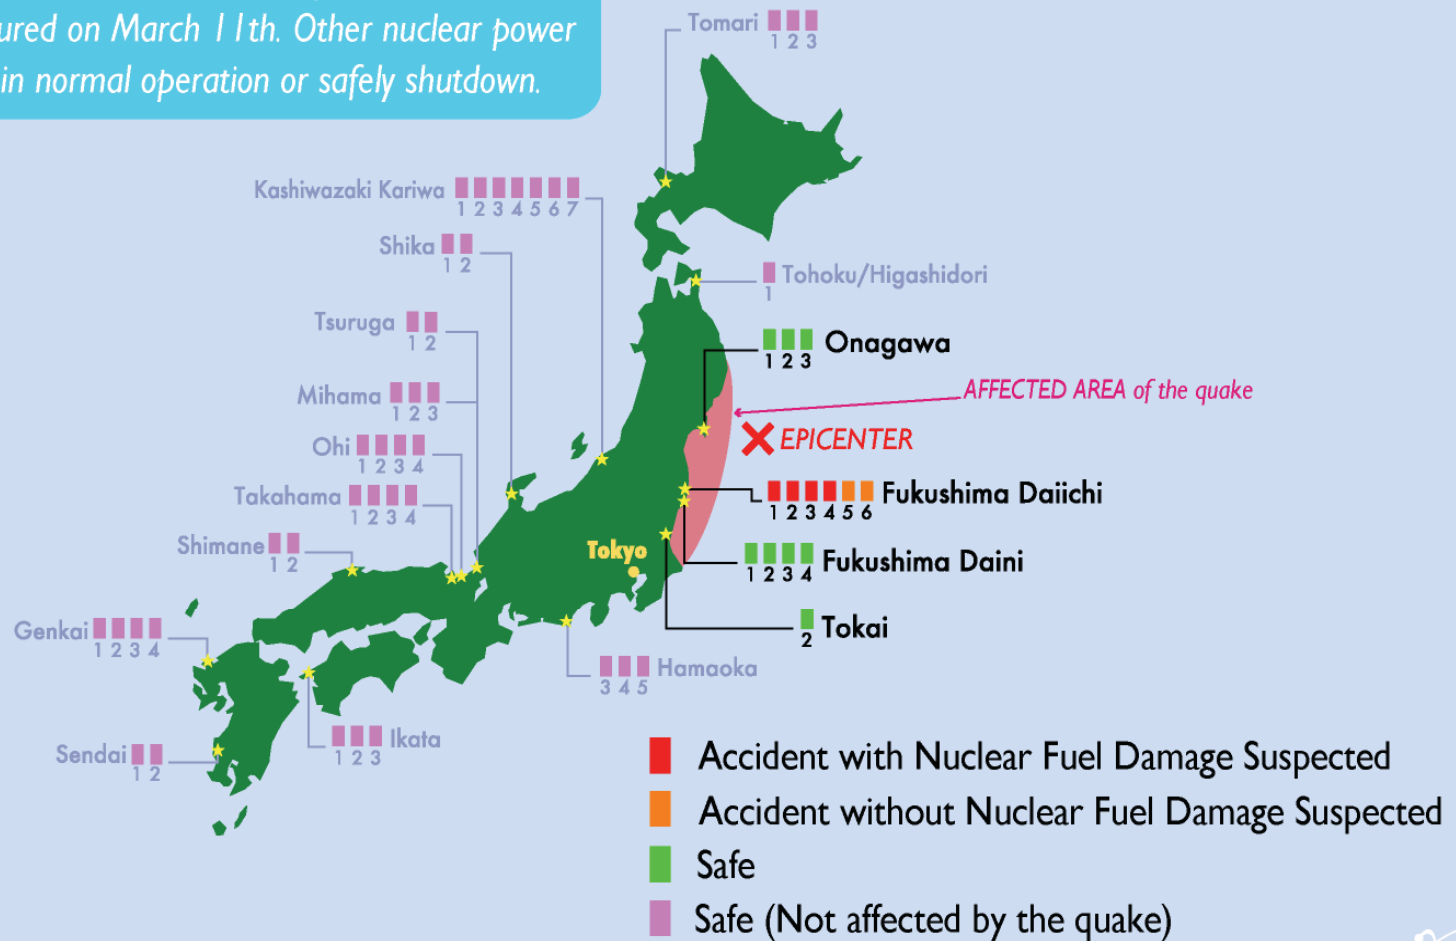
Status of the Nuclear Power Plants after the Earthquake

The accident that brings environmental impact is going on at several units in Fukushima Daiichi nuclear power Station after the earthquake occurred on March 11th. Other nuclear power plants in Japan are in normal operation or safely shutdown.
