Information on Status of Nuclear Power Plants in Fukushima

Japan Atomic Industrial Forum, Inc.

Status of nuclear power plants in Fukushima as of 20:00, April 6th (Estimated by JAIF)

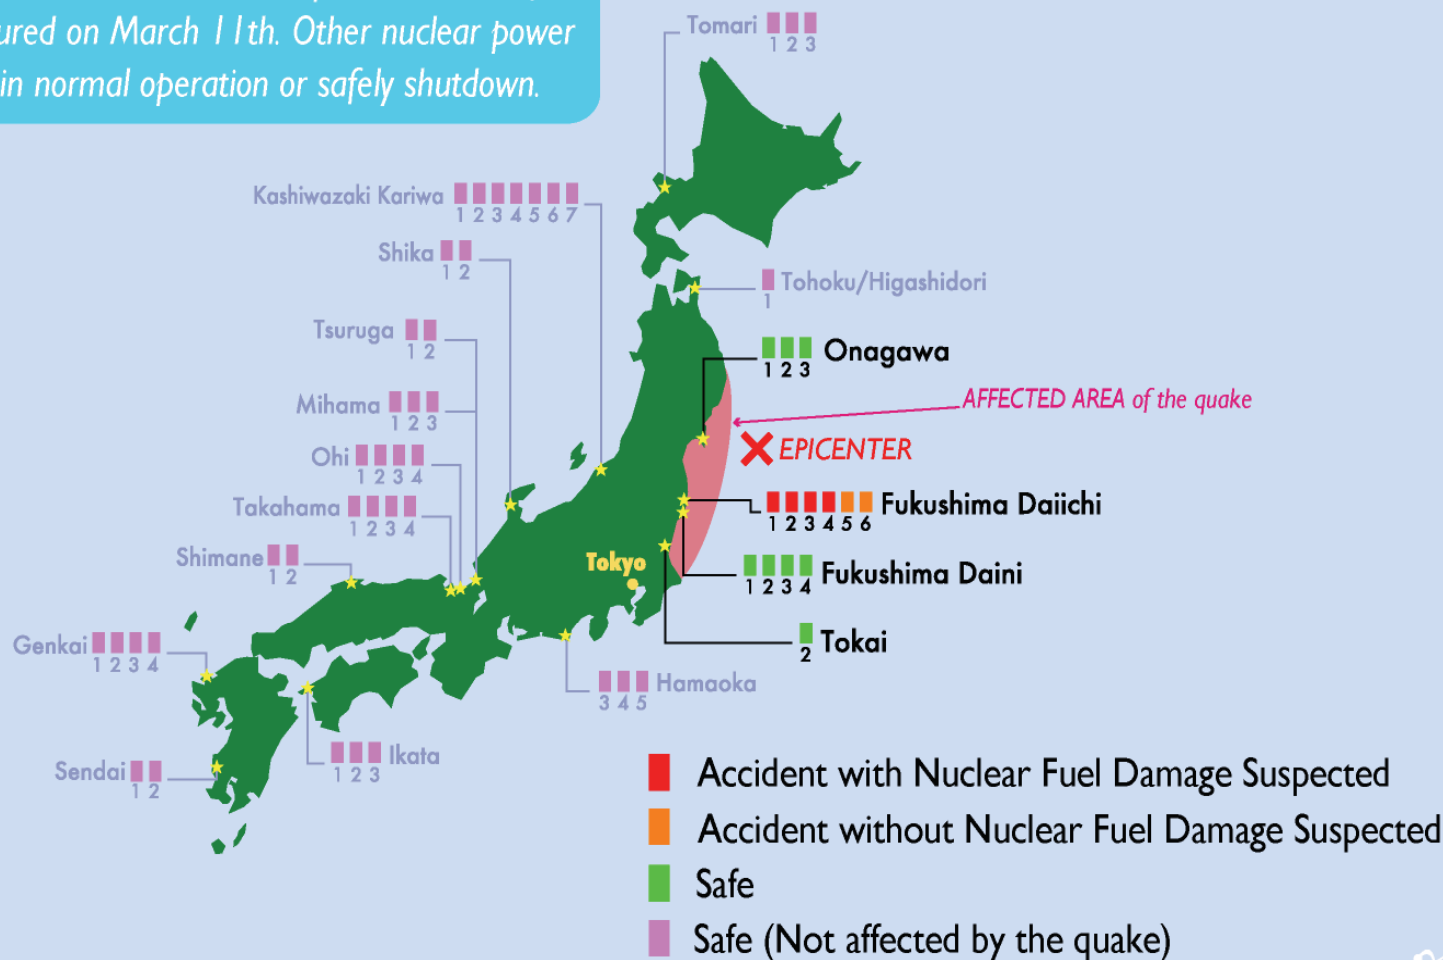
Status of the Nuclear Power Plants after the Earthquake

The accident that brings environmental impact is going on at several units in Fukushima Daiichi nuclear power Station after the earthquake occurred on March 11th. Other nuclear power plants in Japan are in normal operation or safely shutdown.
